Are your 42-12 Scaler Tips due to be replaced?

For the iM3 42-12 Scaler Tip Insert

42-12 Scaler Tip Insert

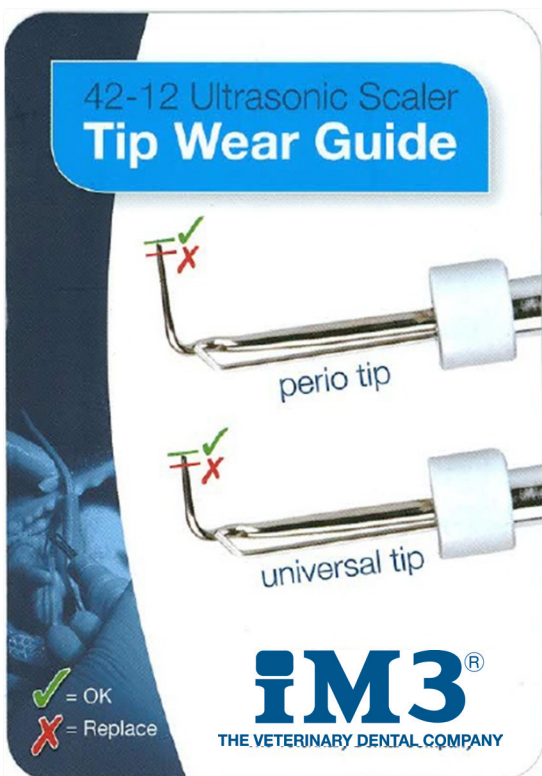
1. Tip wear will significantly reduce scaler performance as it will alter the ultrasonic frequency.
 2. The ferrite rod must be tight – a loose or broken rod will cause poor or no vibration.
 3. A correctly functioning tip used on a power setting of 3-4 lights will produce a coolant mist (no dribble) around the tip.
- Replacement titanium tips and rods available from IM3 or your IM3 distributor.

- All Scaler Tips wear out!
- Worn tips result in reduced vibration on the tooth!
- Worn tips result in inefficient scaling and frustration!
- Worn tips result in poor displacement of water to aid cooling!
- Worn tips result in excess anesthesia and procedure time and money!
- During the working life of the Scaler Tip, display lights and Water Flow will require adjusting!
- Keep the Ferrite Rod from a Worn Tip as a valuable spare!

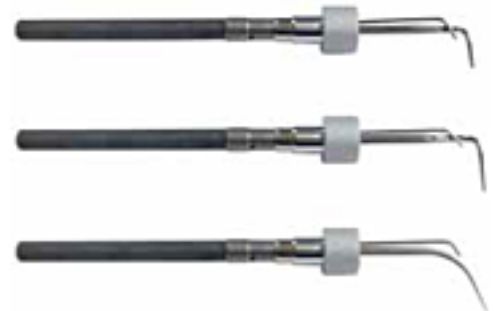
Ferrite Rod

O6860

O6840
Universal Tip

O6850
Perio Tip

O6845
Thinline straight tip is ideal for felines and small mouths.
